The Leaning Tower of Pisa

ABSTRACT: The Leaning Tower of Pisa is one of the world's best known and most treasured monuments. It was erected in the Middle Ages, at the time of maximum power of Pisa. The Tower is founded on highly compressible soils and started leaning from commencement of its construction. In the 1990s the overhang had reached the value of 4.7 m and was increasing at a rate of 1.5 mm per year; an analysis of the situation showed that a collapse was to be expected within some decades.

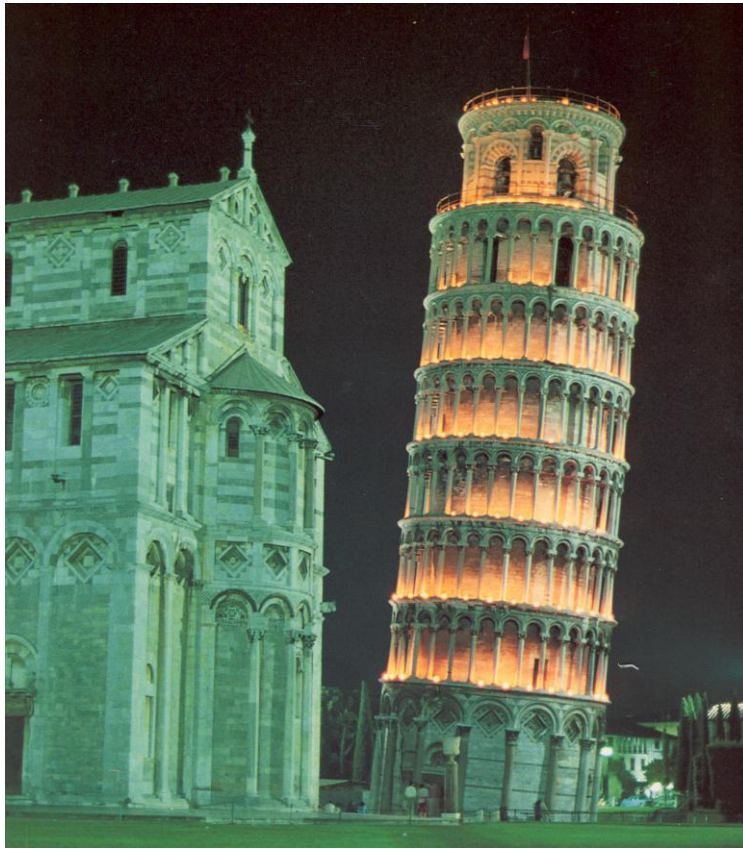
Fig. 1. The Leaning Tower of Pisa

The Leaning Tower (Fig. 1) is one of the best known and most treasured monuments of the world.

Construction is in the form of a hollow cylinder surrounded by six loggias with columns and vaults merging from the base cylinder and surmounted by a belfry. The structure is thus subdivided into eight segments, called "orders".

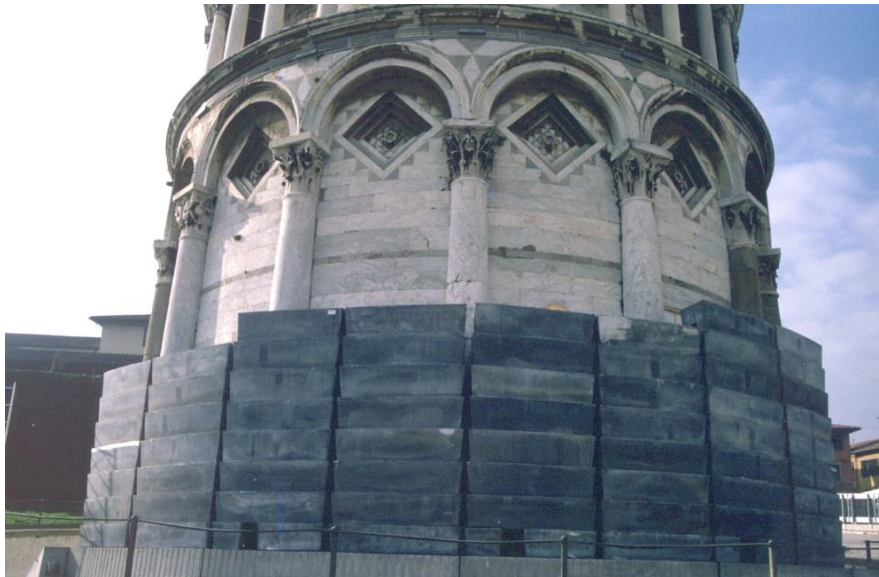
Fully aware that a long time was needed to conceive, design and implement the permanent stabilization measures, the Committee took an early decision to implement temporary and fully reversible interventions to slightly improve the safety against overturning, and to gain the time to properly devise, design and implement the permanent solution. A total of 6.9 MN of lead ingots were installed between May 1993 and February 1994 on the north edge of the base of the Tower (fig. 21). They induced a change of inclination of 33" by February 1994; by the end of July it had increased to 48" and eventually to 53". By February 1994 the average additional settlement of the tower relative to the surrounding ground was about 2.5 mm. The settlement and rotation produced by the counterweight had been predicted by the finite element model; the agreement between prediction and observation was satisfactory, increasing the confidence in the model. An event of the utmost importance is that the progressive southward inclination of the Tower came to a standstill.

Fig. 21. The provisional intervention by lead ingots counterweight

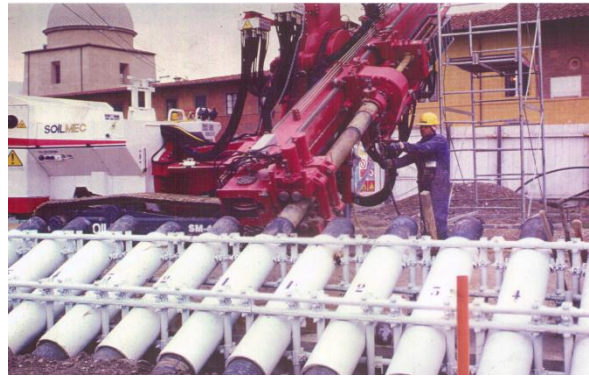
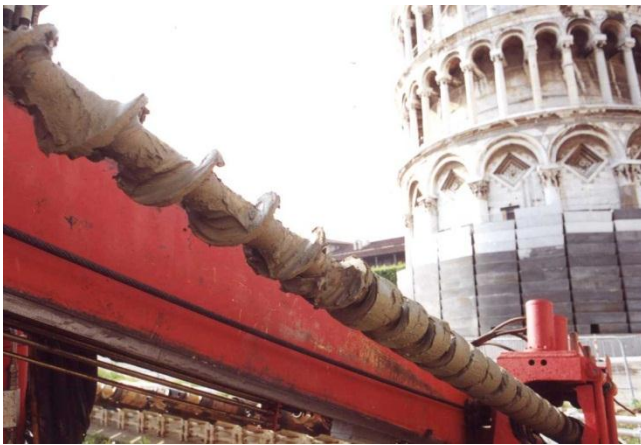
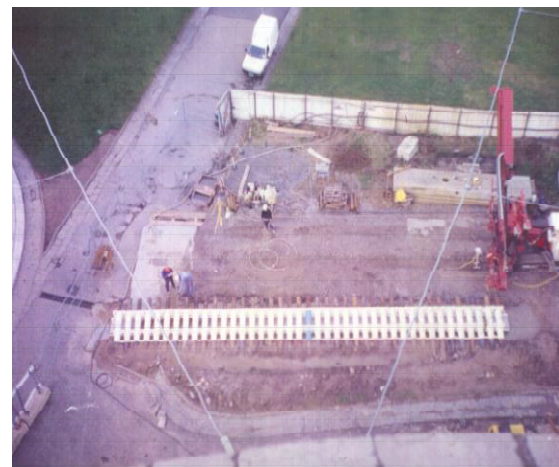
Fig. 25. The underexcavation

After the very positive results of the preliminary underexcavation, the Committee went on steadily to the full underexcavation (fig. 25). It was carried out between February 21, 2000 and June 6, 2001, with 41 holes, removing a total of 38 m³ of soil (70% below the catino, *i.e.* outside the perimeter of the foundation) involving 1737 single extractions. In the same period all the lead ingots were progressively removed. In June 2001 the steel cable stays were dismantled, without ever having been operated.
