Leaning Tower of Pisa: Behaviour after Stabilization Operations

ABSTRACT: It is well known that the foundations of the Leaning Tower of Pisa were stabilised using the method of underexcavation to reduce the southward inclination of the Tower by about 10 percent in combination with controlling the seasonally fluctuating water table beneath the north side. Having been closed to the public since early in 1990, the Tower was re-opened in December 2001. The paper summarises the response of the Tower during the period of implementation of the stabilisation works. Monitoring of the movements of the Tower has been continuing and the observations obtained since 2001 are presented. It is shown that over the six years between 2003 and 2008 the induced rate of northward rotation of the Tower has been steadily reducing to less than 0.2 arc seconds per year. Similarly the rate of induced settlement of the centre of the foundation has been steadily reducing and is approaching the background rate of settlement of the Piazza. Piezometer measurements close to the north side of the foundation shows that the drainage system has been successful in stabilising the groundwater levels beneath the north s

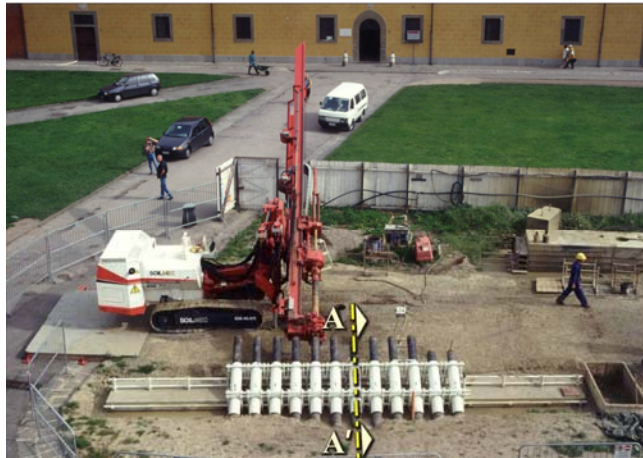
Figure 9. Holes for preliminary underexcavation.

Preliminary underexcavation Extraction hole - Section A-A'

In August 1998 the Committee agreed to carry out limited soil extraction from beneath the Tower with a view to observing its response. This preliminary underexcavation was to be carried out over a limited width of 6m north of the Tower using twelve bore holes lined with 219mm diameter casings (Fig. 9). On 9th February 1999, in an atmosphere of great tension, the first soil extraction took place. The Tower slowly began to rotate northwards. When the northward rotation had reached about 80 arc seconds by early June 1999 the preliminary soil extraction was stopped. Northward rotation continued at a decreasing rate until October 1999.
